Manhole Inspection Summary

Manhole # S09OO_026MH

Insp Date: **8/9/07 7:36 AM**

Location Address: **DENISON AVE**

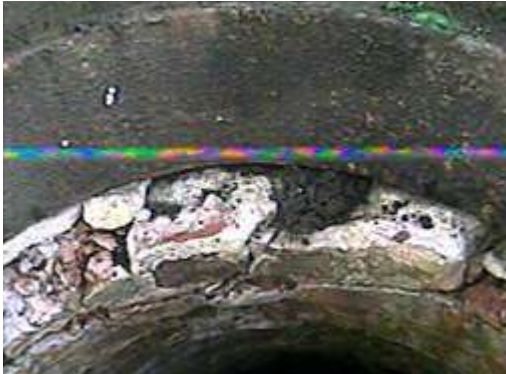
Defect 2

Condition: ☐ Sound ☒ **Cracked** ☐ Root Intrusion ☒ **Loose Brick** ☐ Deteriorated

CRACKED CORBEL

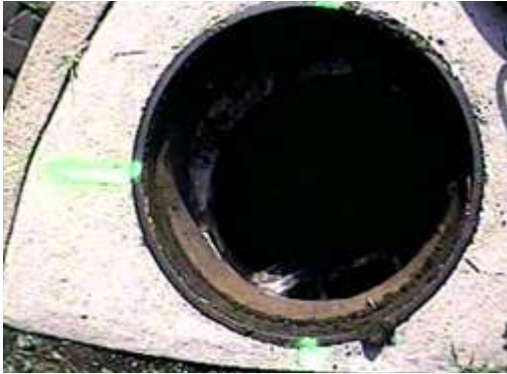
Defect 3

Offset: **3** (in.)

OFFSET FRAME

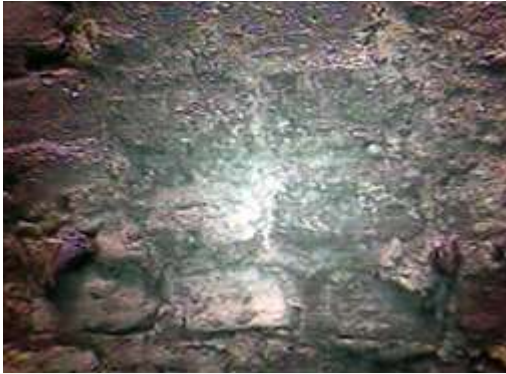
Defect 1

Count: **3** Missing: **2** ☒ **Corroded**

MISSING RUNG

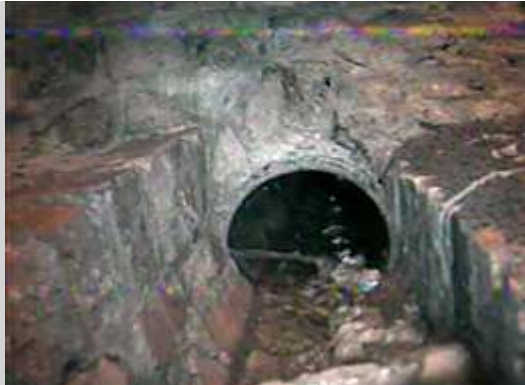
12 O'Clock Outflow

Pipe Height: (in.) Direct
Pipe Material: **Clay** ☐ Pipe Lined
Invert Depth: **6.55** (ft.) Flow Characteristics: **Slow**
Deposits: ☐ None ☐ Mud ☐ Sludge ☒ **Debris** ☐ Grease
Silt Depth: **1** (in.) Deposits Extent: **Light**
Infiltration: **None** Pipe Seal Cond: **Sound**

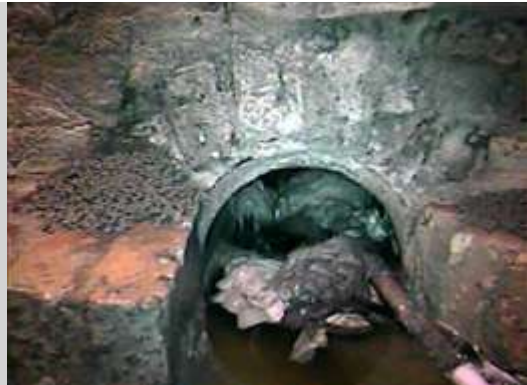
9 O'Clock Inflow

Deposits: ☐ None ☐ Mud ☐ Sludge ☒ **Debris** ☐ Grease

Silt Depth: **3** (in.) Deposits Extent: **Medium**
